PEMBROKE COTTAGE MAIN DAM
ME 00294
AND
EAST DAM
ME 00721

PHASE I INSPECTION REPORT
NATIONAL DAM INSPECTION PROGRAM

SEPTEMBER 1981

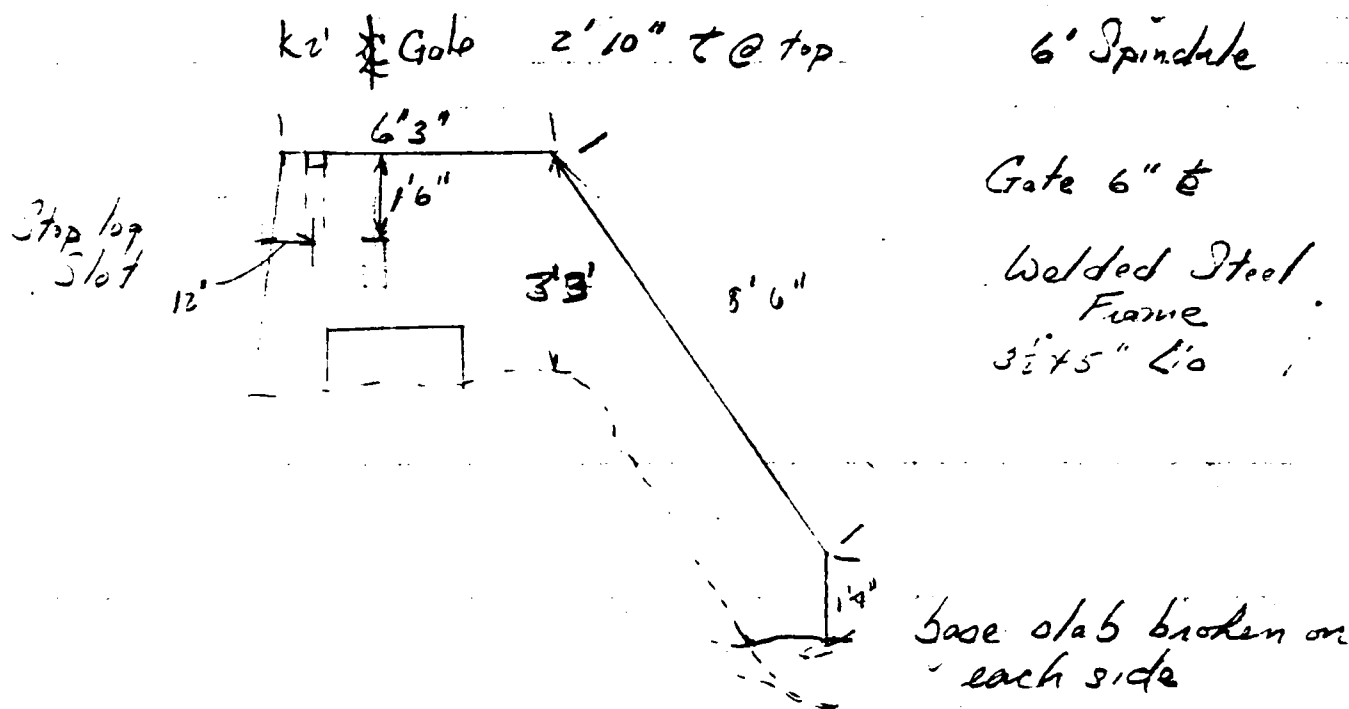
Client Corps of Engineers Job No. 1345-07E Sheet 10 of 11
 Subject Field Notes East Dam By GDS Date _____
 Ckd. _____ Rev. _____

Extensive Cracks on Spillway Side wall water
 seen seeping out @ base just down stream of
 gate. Base slab has separated from wall
 bedrock observed on outer face of each wall
 but not on inner face
 Gate was leaking @ base

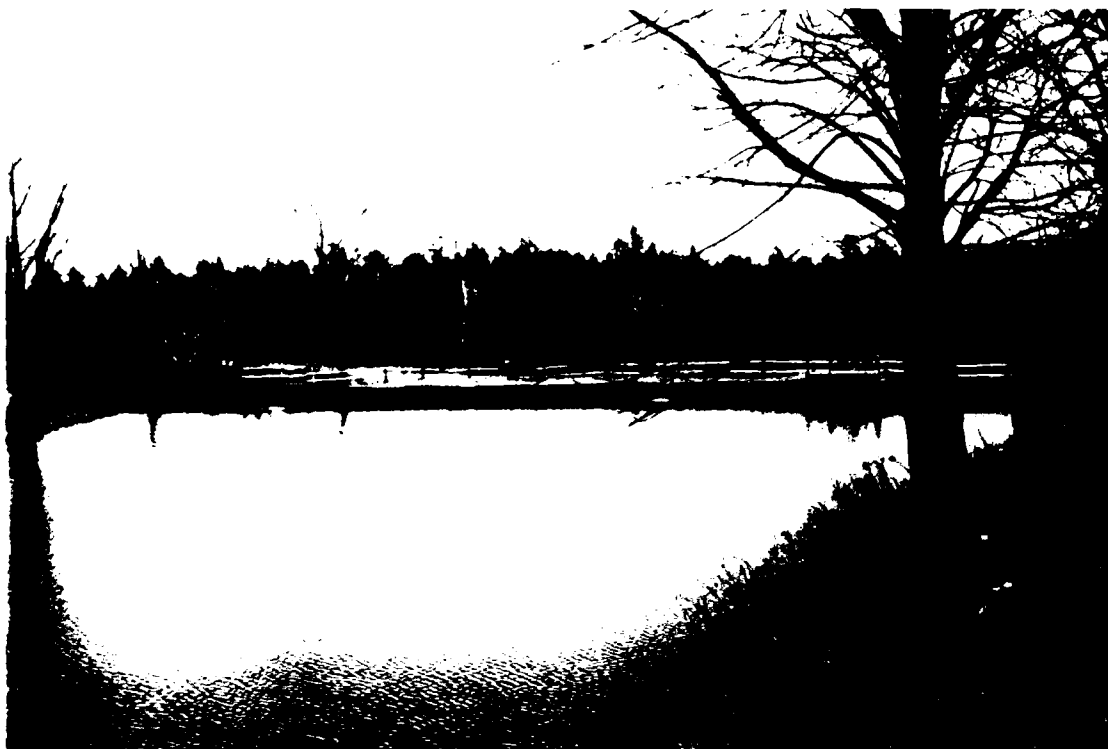
The concrete wall on the upstream face is exhibiting signs of distress. Within the 4 foot zone visible during the inspection, several hairline longitudinal cracks 20-60 feet in length were noted. Some efflorescence was also noted. The zone at the waterline was experiencing spalling due to ice action.

No. 3
Main Dam from
Reservoir Area

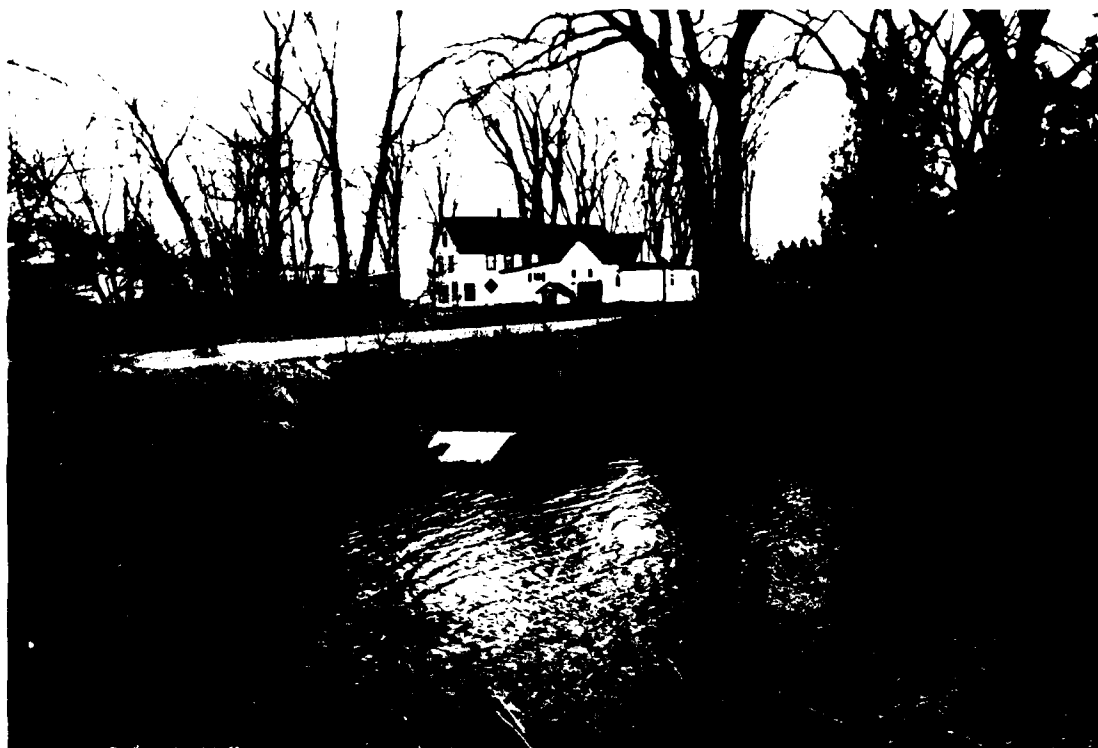
- d. Reservoir Area - The pond area directly controlled by the Main dam is about 300 feet long and 200 feet wide at the dam. A small dam (North dam) and the 36" Ø culvert under the roadway (See Photos No. 7 & No. 8) control the flow to the pond. The pond is bordered by a forested Puttys Island on the left shore and a light residential zone on the right shore.
- e. Downstream Channel - The downstream channel was clear with no evidence of debris. The masonry wall lining the channel was generally in good condition as was the recently constructed concrete wall.

No. 7
View from Upstream
of 36"Ø CMP at
roadway

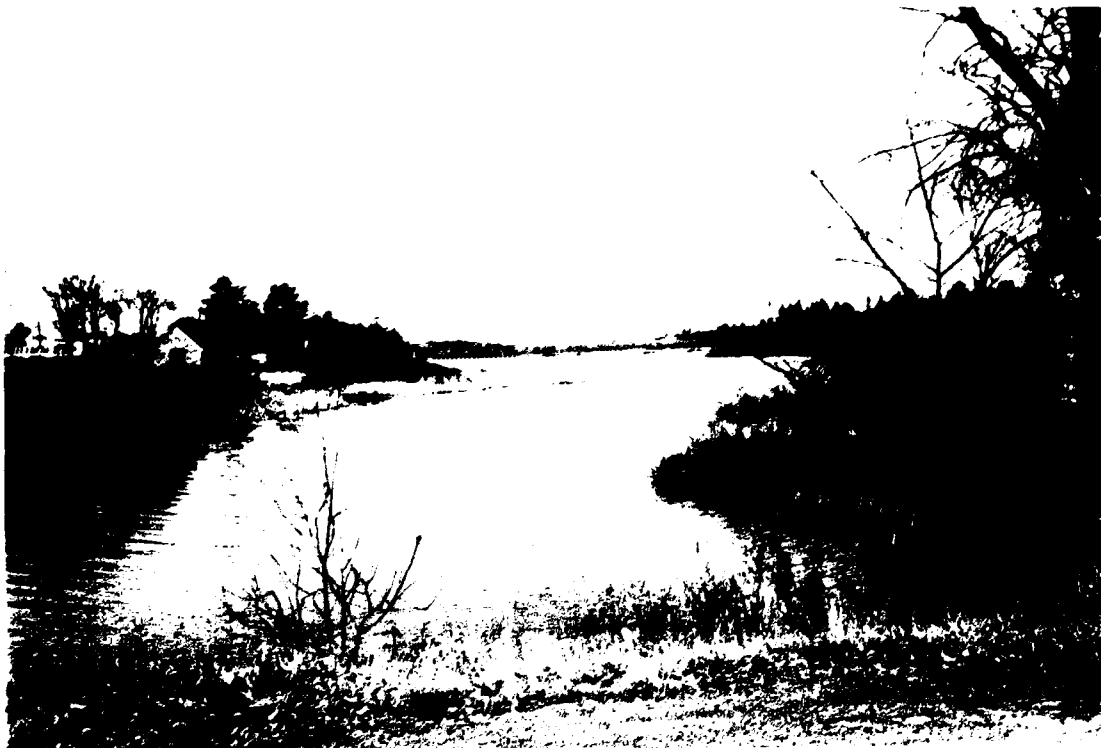
No. 9
View of Reservoir
Area from Roadway
at North Dam

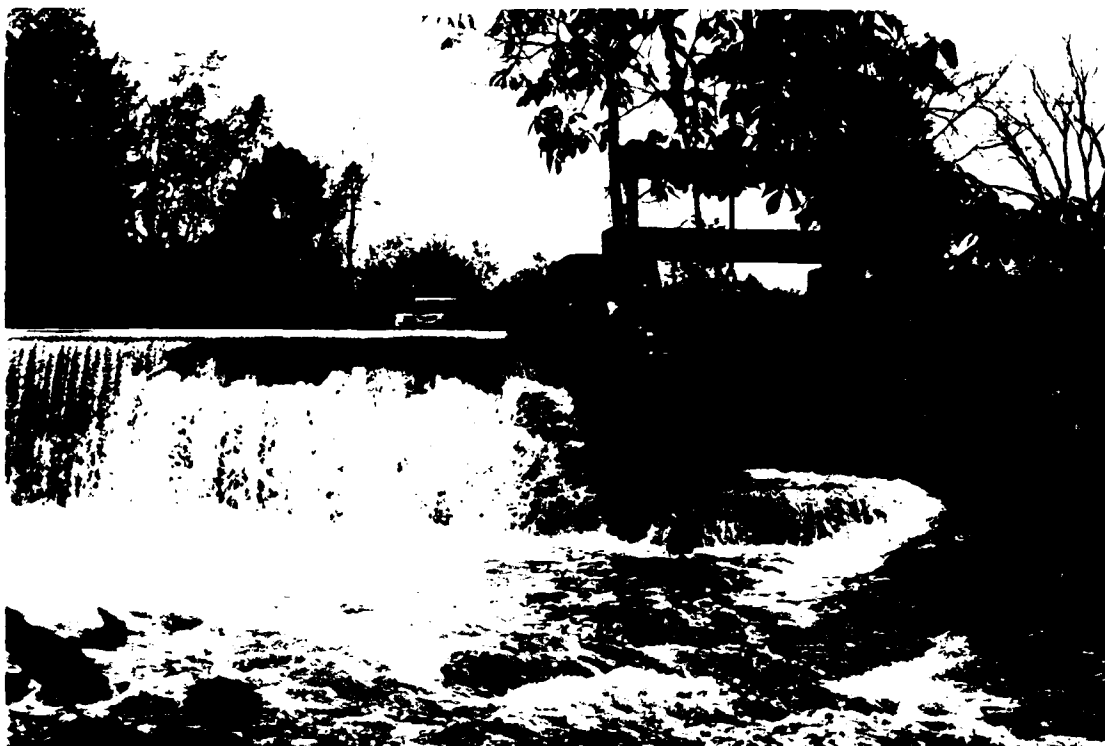
The small section which allows flow to the fishways is generally in good condition. The concrete is experiencing minor spalling. The sluices are slotted for flashboards and 6" were in place at the time of inspection.

No. 14
Sluiceway Openings
to Fishway
